HAYES MARINE SURVEYORS

VESSEL SURVEY REPORT

VESSEL:		DOC/REG #:	[Documentation #]
BUILDER:	Hunter Marine	HIN #:	[HIN #]
MODEL:	460	YEAR:	2000
TYPE:	Sailboat	DESIGNER:	Hunter Marine
RIG:	Sloop	HULL MAT:	Fiberglass
POWER:	Single Diesel	LOA:	46' 0"
SAIL AREA:	.	LWL:	38' 7"
CRUS SPEED:	5 knots	BEAM:	14' 0"
MAX SPEED:	8 knots	DRAFT:	5' 6"
FUEL CAP:	94 gal.	WGT/DISP:	26,000 lbs.
WATER CAP:	200 gal.	BALLAST:	9,500 lbs.

TYPE OF SURVEY: Condition & Value **DATE OF SURVEY:** August 8, 2013
August 22, 2013

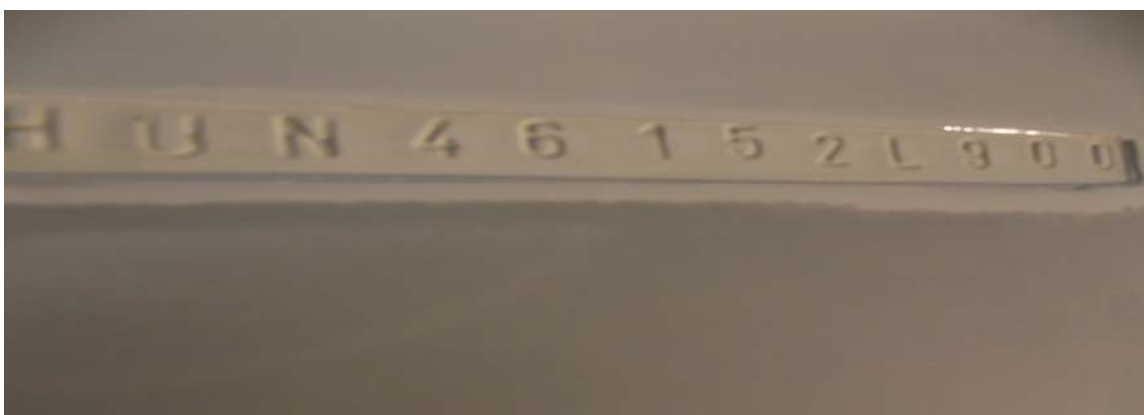
True Digital Photo of Vessel HIN
