HAYES MARINE SURVEYORS

VESSEL SURVEY REPORT

VESSEL:		DOC/REG #:	[Documentation #]
BUILDER:	Hunter Marine	HIN #:	[HIN #]
MODEL:	460	YEAR:	2000
TYPE:	Sailboat	DESIGNER:	Hunter Marine
RIG:	Sloop	HULL MAT:	Fiberglass
POWER:	Single Diesel	LOA:	46' 0"
SAIL AREA:	.	LWL:	38' 7"
CRUS SPEED:	5 knots	BEAM:	14' 0"
MAX SPEED:	8 knots	DRAFT:	5' 6"
FUEL CAP:	94 gal.	WGT/DISP:	26,000 lbs.
WATER CAP:	200 gal.	BALLAST:	9,500 lbs.

TYPE OF SURVEY: Condition & Value **DATE OF SURVEY:** August 8, 2013
August 22, 2013

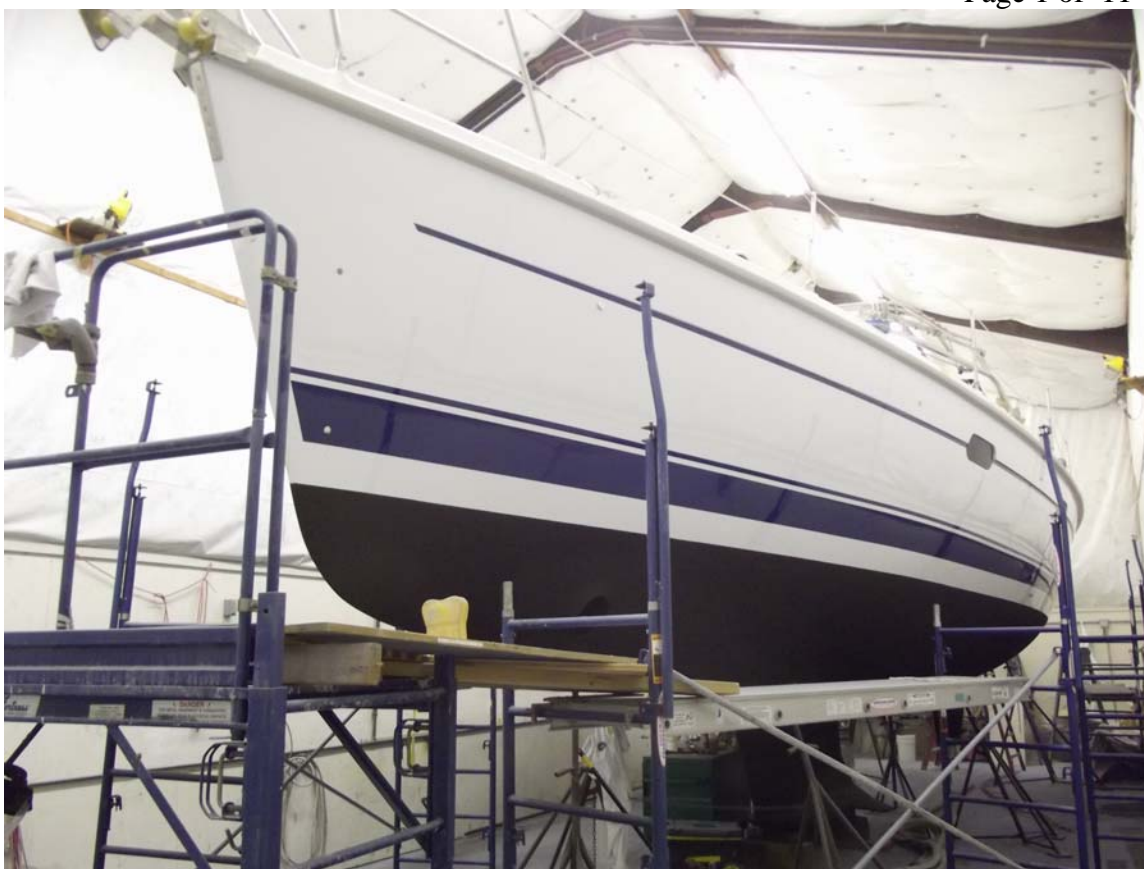
HUNTER 460

The vessel was located at Brewers Stratford Marina, 605 Broad St., Stratford, CT. The vessel was on land in a work shed undergoing the final stages of structural and cosmetic upgrades at the time of the initial inspection. The boat was re-inspected on August 22, 2013 while the boat was still in the work shed. The vessel was extensively rebuild after being severely damaged during Hurricane Sandy
